LIME SCALE REMOVAL IN RAND WATER PIPELINES – INSTOLATION SITE: ZUIKERBOSCH PUMP STATION PO: 45002150384 Supplier No: 119370

## Overview

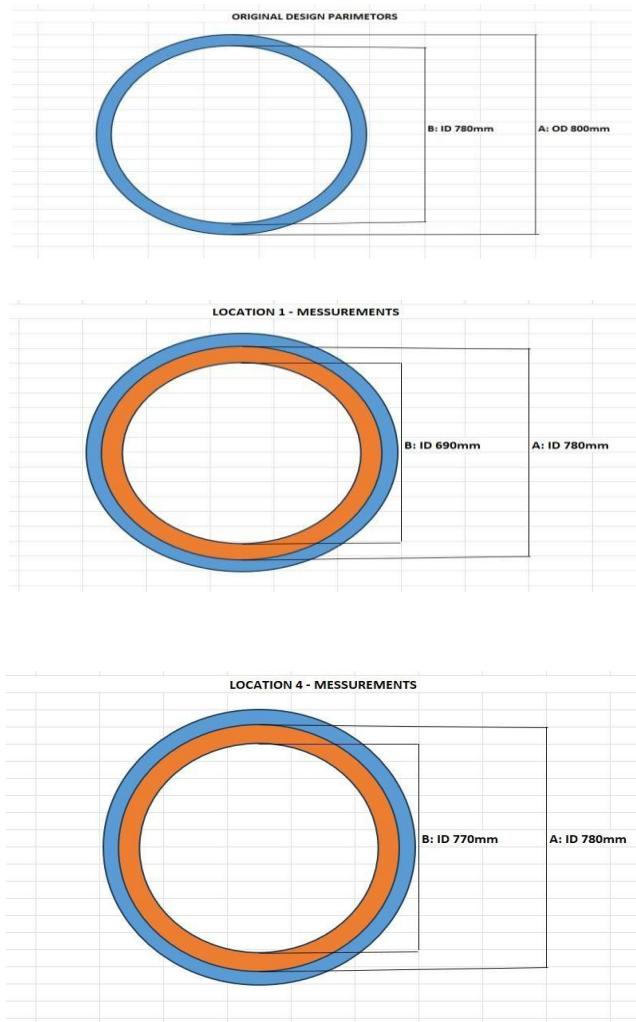
1. **Limescale Removal:** The Merus Ring installation effectively eliminated existing limescale deposits, which had previously reduced the effective internal diameter of the pipelines from 800mm to approximately 480mm. Post-installation measurements indicated a substantial increase in the effective diameter, with an average internal diameter of around 700mm at Inspection Hatch No: 2 and 690mm at Inspection Hatch No: 1. This demonstrated a more uniform layer of limescale buildup compared to areas without the installation.

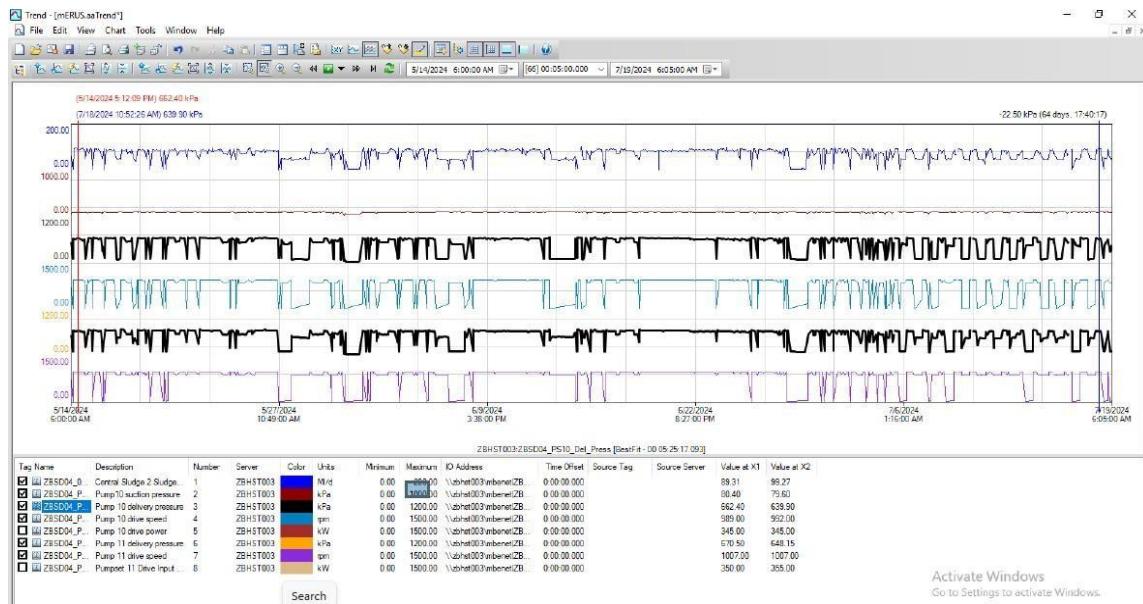
## Trend Merus ring, Flow Measurements

An inspection conducted in August 2024 confirmed the effectiveness of the Merus Ring in reducing limescale buildup, with measurements showing increased internal diameters at various inspection points along the pipeline.
